Subject: Clean Water Act Compliance Evaluation Inspection Report

CWA COMPLIANCE EVALUATION INSPECTION REPORT
U.S. ENVIRONMENTAL PROTECTION AGENCY, REGION 5

Facility: Calamity Knoll

Date of Inspection: April 24, 2014

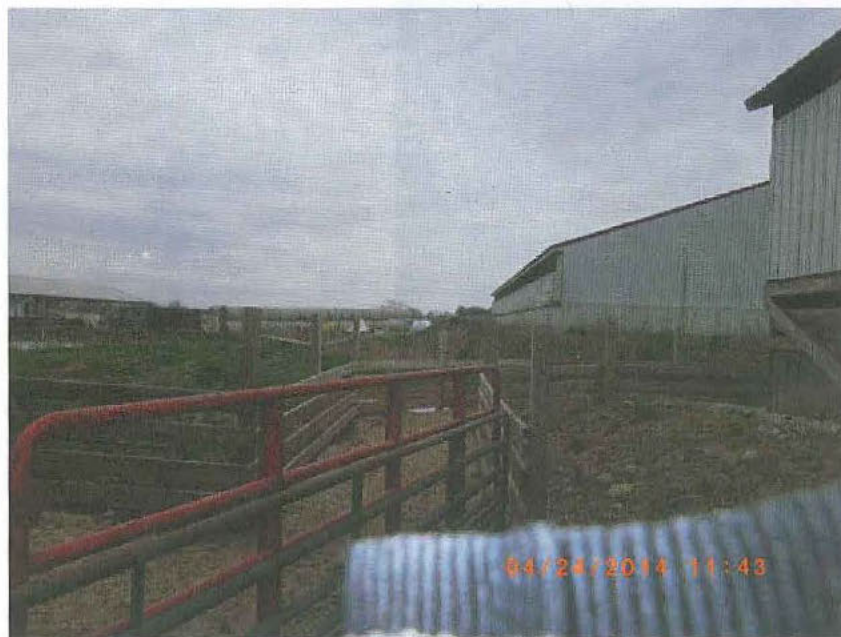
2: IMGP0628

I observed animal walkways near the Arnold and Sayle's Barn (Attachment 2: IMGP0627; IMGP0628). Portions of the walkway were sloped such that runoff from the animal walkway would flow toward the east to a pathway along the south end of the Coughlin Pit. The pathway hugs the south and then the east side of the Coughlin pit. Within this pathway at the southeast corner of the Coughlin pit, there was dark and septic smelling water (Attachment 2: IMGP0630; IMGP0631). There was dead vegetation throughout the pathway (Attachment 2: IMGP0630; IMGP0632). This pathway connected with a culvert at the northeast end of the Coughlin pit, which ran east under the access road and outlet into a pathway along the south side of Hartgarten Barn (Attachment 2: IMGP633). The pathway continues east along the south side of the Hartgarten Barn (Attachment 2: IMGP0635). The surface drainage then followed the general direction as exhibited in the diagrams in Attachment 1.

Description: The animal walkway contained some manure and drained toward the east.

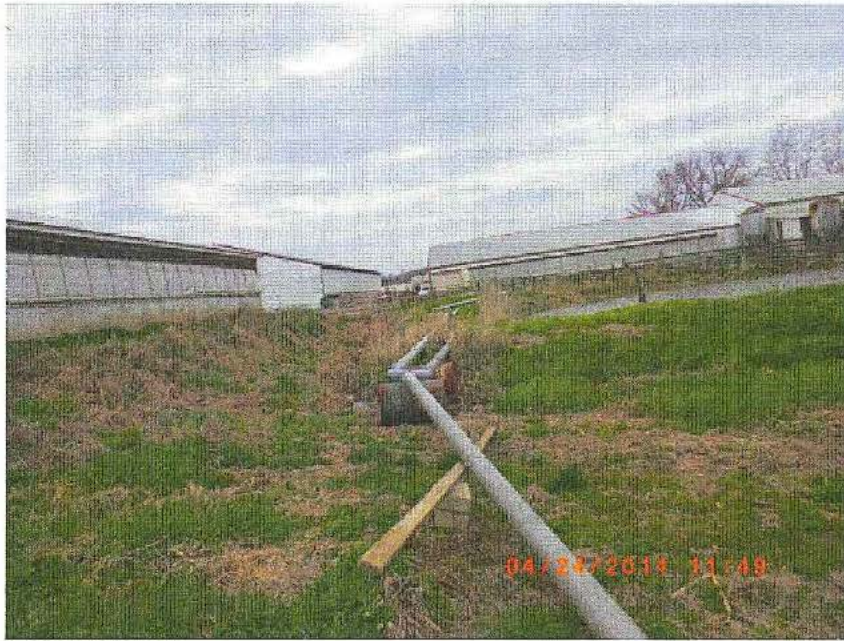
3: IMGP0629

Description: The topography of this area is such that surface flow from the animal walkway and roof runoff drains through a pathway east along the south side of the Coughlin Pit and then north along the east end of the Coughlin Pit. Irrigation pipes were set up for pumping from the Coughlin Pit.

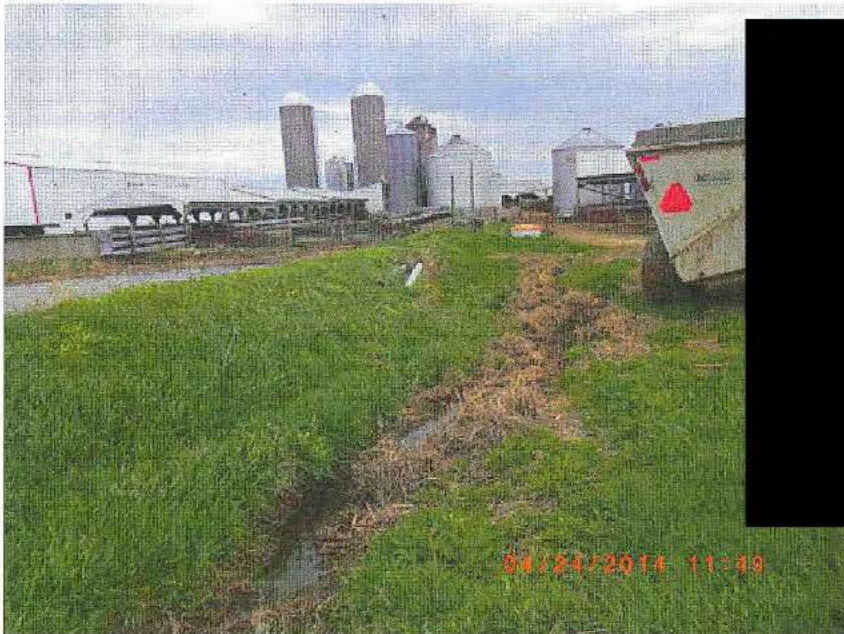
4: IMGP0630

Description: Drainage pathway flows north. There was dead vegetation throughout the pathway.

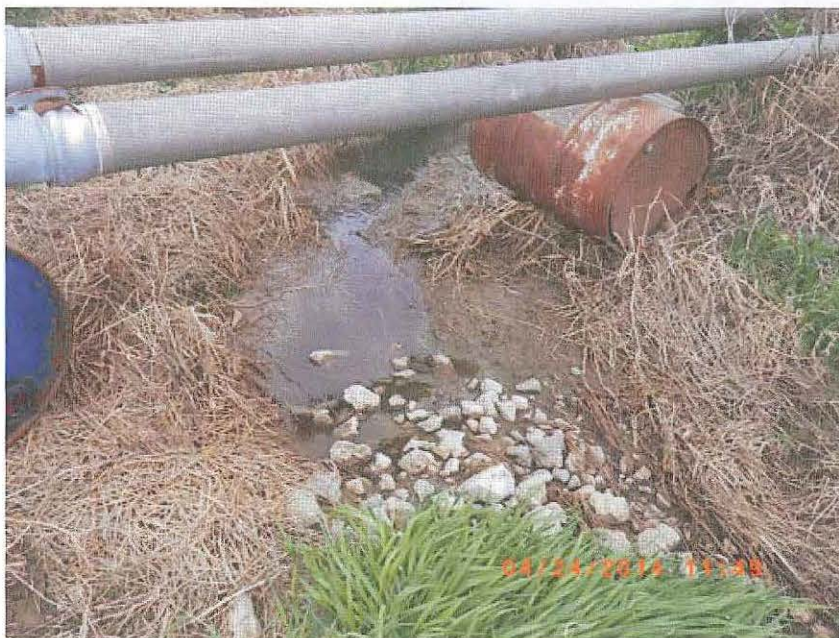
5: IMGP0631

Description: The water in the pathway was dark and septic.

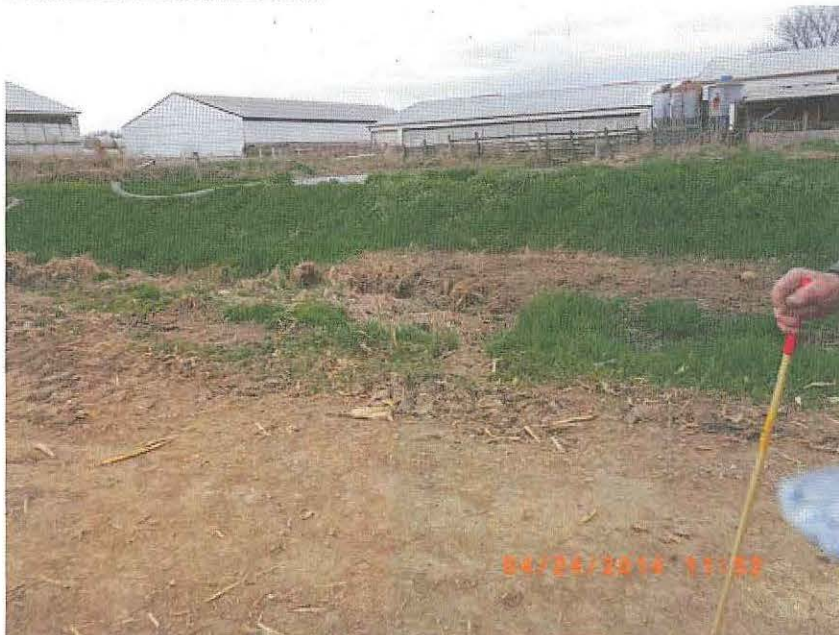
6: IMGP0632

Description: The pathway continued north along the Coughlin Pit before connecting through a culvert under the access road that outlet near the southwest end of the Hartgarten Barn.

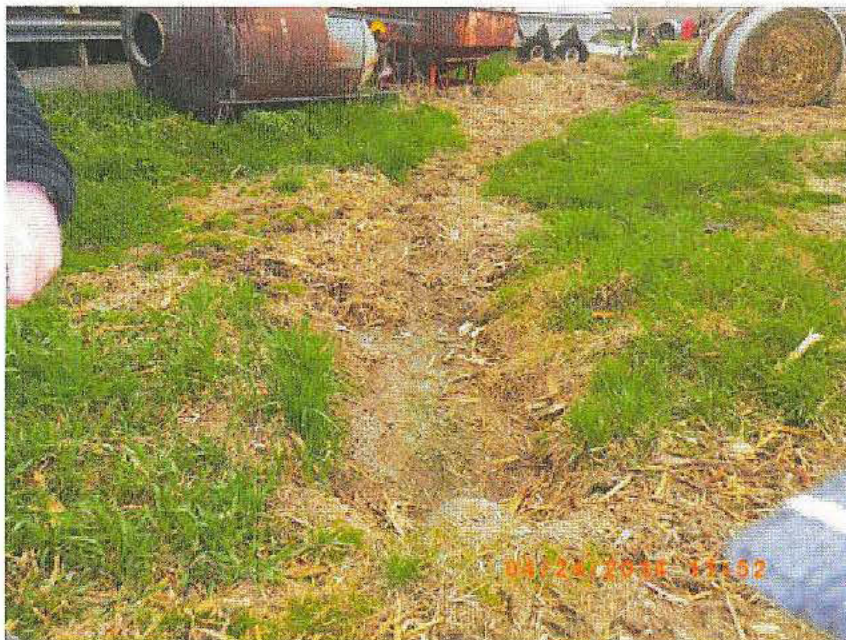
7: IMGP0633

Description: The pathway continued east along the south side of the Hartgarten Barn. There was dead vegetation throughout the pathway.

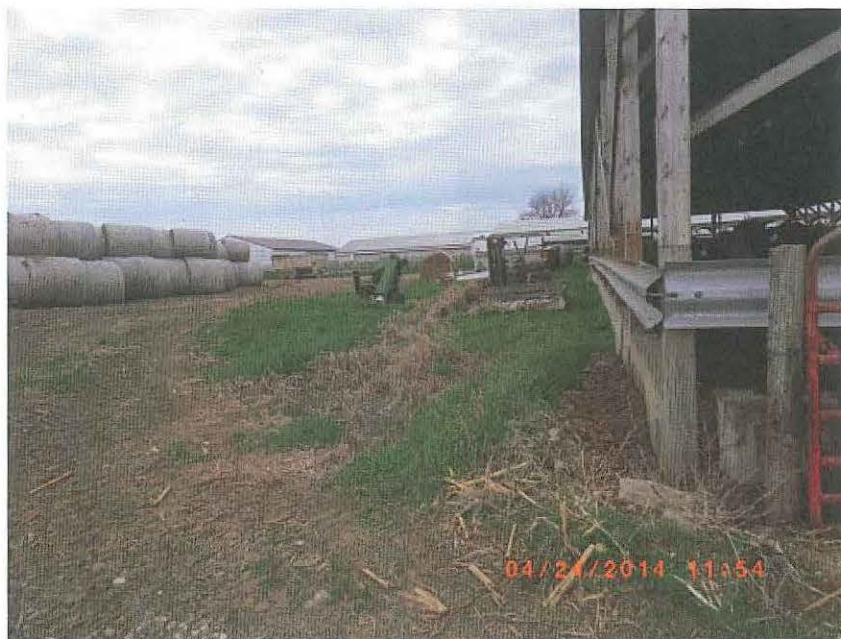
9: IMGP0635

Description: Drainage pathway along south end of Hartgarten Barn. There was dead vegetation throughout the pathway.

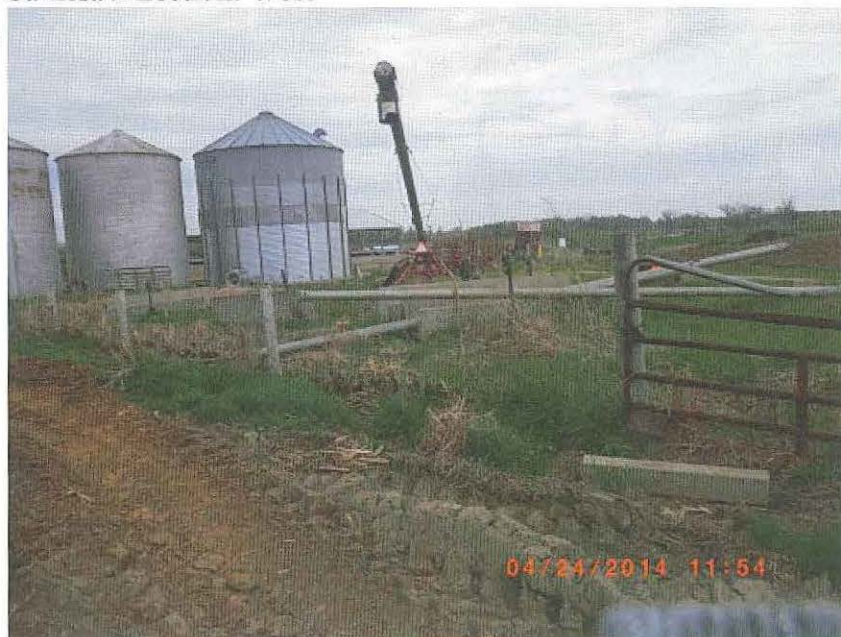
10: IMGP0636

Description: The topograph of the area was sloped such that drainage from along the south end of the Hartgarten Barn and from between the Hartgarten and Cow Palace Barn drained through a vegetated area to the east of Hartgarten Barn.

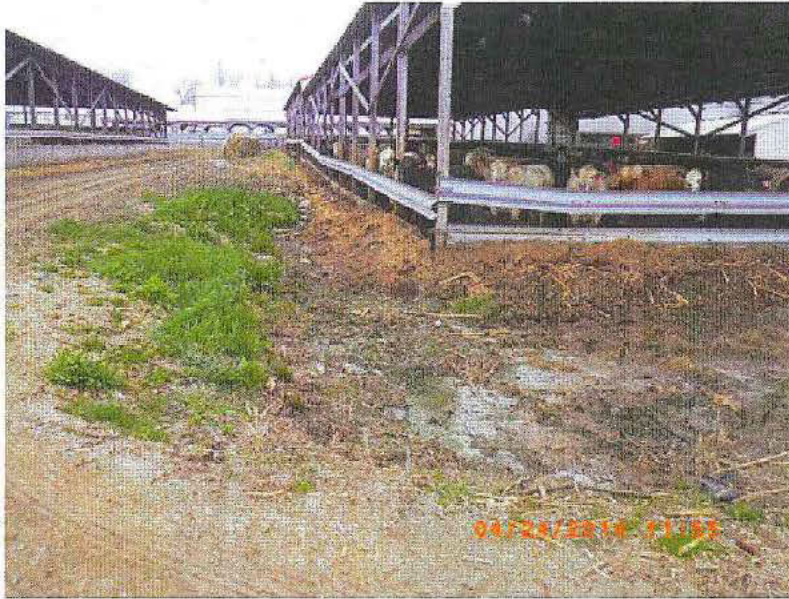
11: IMGP0637

In the southeast corner of Cow Palace, there was a culvert going under the access road to the east (Attachment 2: IMGP0637). Surface drainage flowing into this culvert would come into contact with manure and bedding around the outside of the Cow Palace (Attachment 2: IMGP0637; IMGP0638). I observed manure and bedding solids around and leading up to the entrance of the culvert. The culvert outlet to the east. I observed manure and bedding solids around the outlet of the culvert (Attachment 2: IMGP0640; IMGP0641; IMGP0642; IMGP0643). I observed manure and bedding solids throughout a pathway in the vegetated area that the culvert outlet into. Dead vegetation was observed throughout the vegetated area pathway. The Gilt Shed had open lots. Surface runoff from the open lots had no containment and would flow east (Attachment 2: IMGP0644) ^{Ex. 6. (Personal Privacy)} said that they have placed straw bales east of the Gilt Shed in the past to reduce runoff of manure from the Gilt Shed.

Description: A culvert near the southeast end of the Cow Palace Barn drains the area around the Cow Palace Barn to the east. There was a berm around the perimeter of the barn. The berm contained manure and bedding. Manure and bedding were observed on the ground around the intake of the culvert.

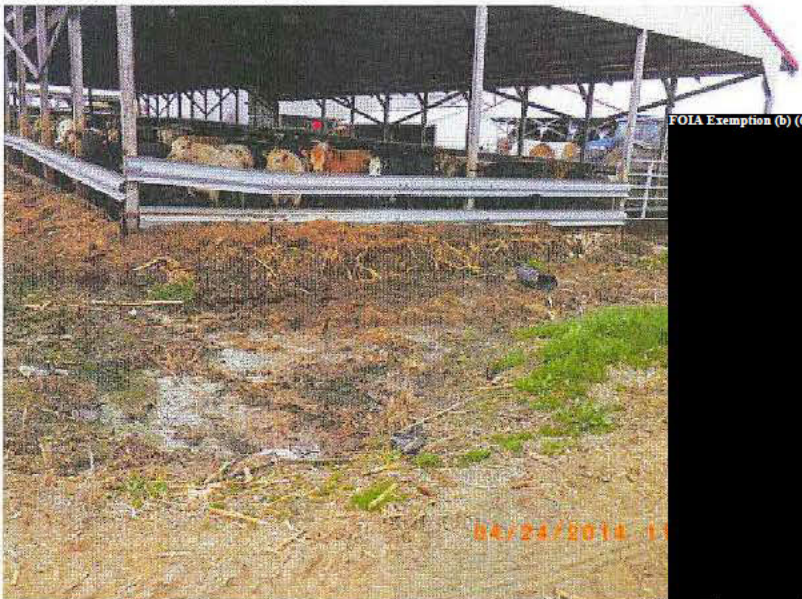
12: IMGP0638

Description: A culvert near the southeast end of the Cow Palace Barn drains the area around the Cow Palace Barn to the east. There was a berm around the perimeter of the barn. The berm contained manure and bedding. Manure and bedding were observed on the ground around the intake of the culvert.

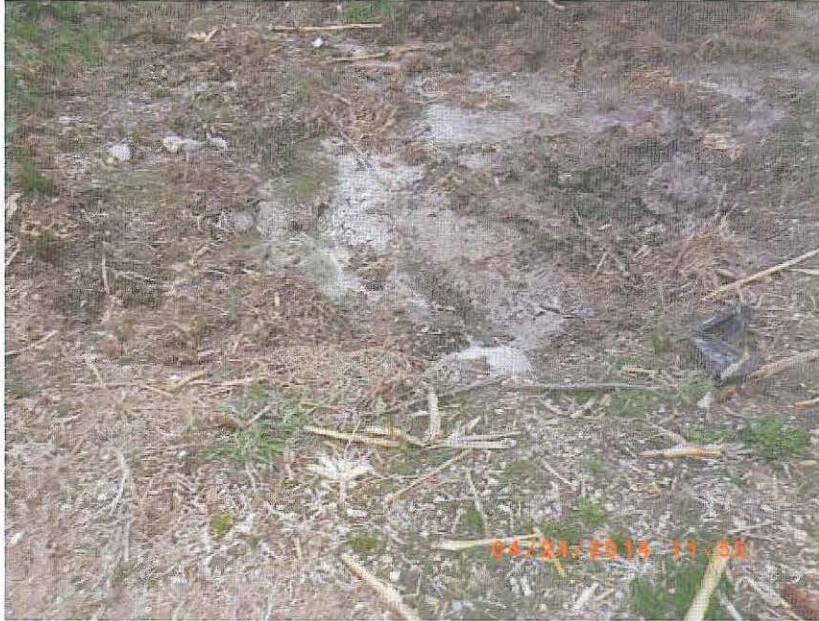
13: IMGP0639

A culvert near the southeast end of the Cow Palace Barn drains the area around the Cow Palace Barn to the east. There was a berm around the perimeter of the barn. The berm contained manure and bedding. Manure and bedding were observed on the ground around the intake of the culvert.

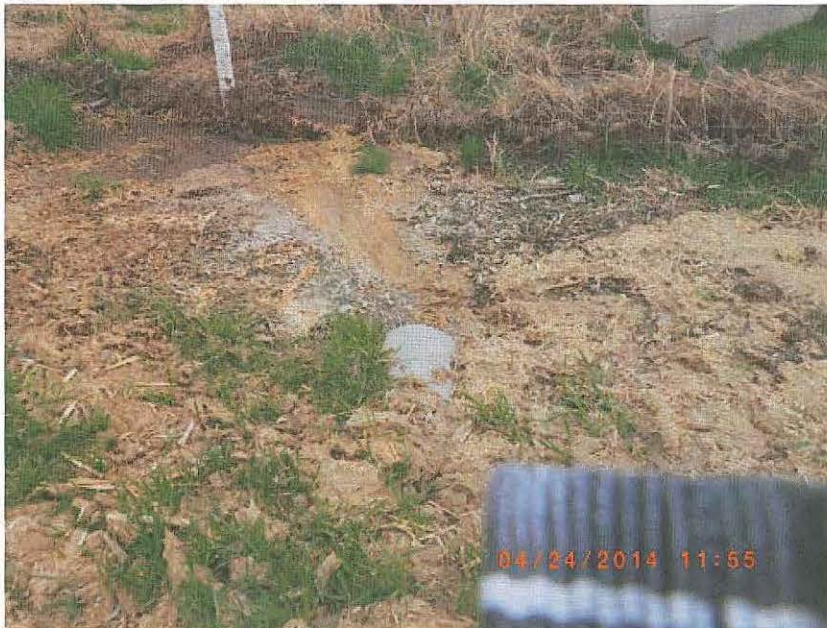
14: IMGP0640

Description: The culvert runs under the access roadway and outlets to a grassed area east of the Cow Palace. Manure and bedding solids were observed around the culvert outlet and into the pathway through the grassed area.

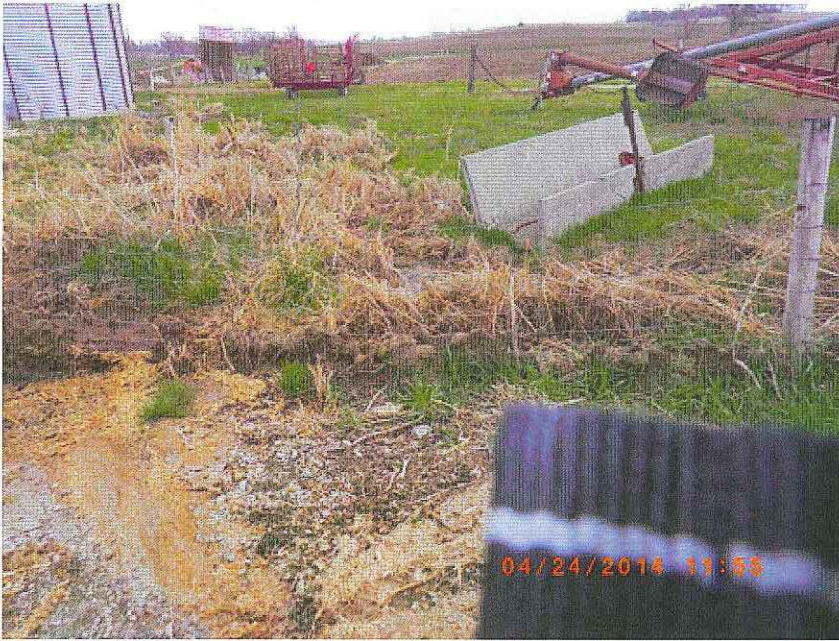
15: IMGP0641

Description: The culvert runs under the access roadway and outlets to a grassed area east of the Cow Palace. Manure and bedding solids were observed around the culvert outlet and into the pathway through the grassed area.

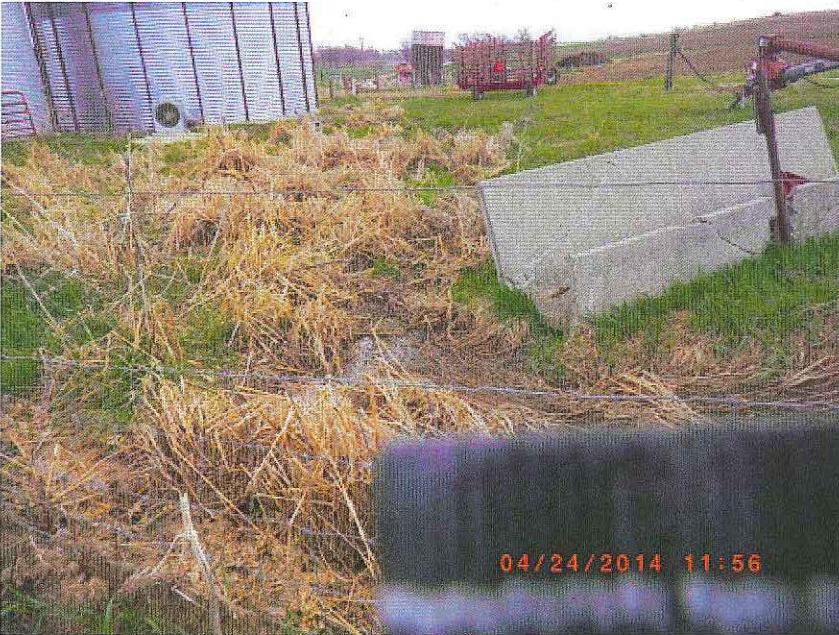
16: IMGP0642

Description: The culvert runs under the access roadway and outlets to a grassed area east of the Cow Palace. Manure and bedding solids were observed around the culvert outlet and into the pathway through the grassed area.

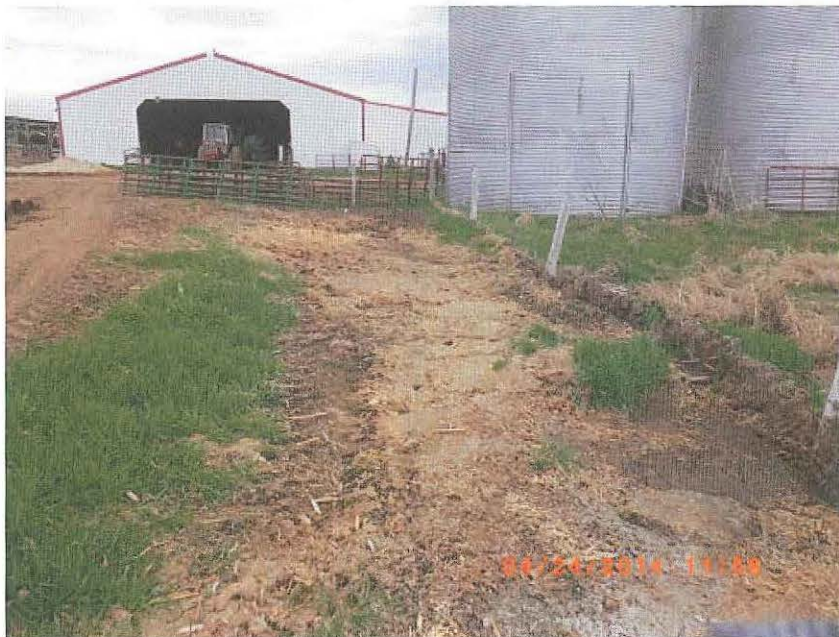
17: IMGP0643

Description: Manure and bedding solids were observed throughout the east end of the Cow Palace and into the pathway through the grassed area.

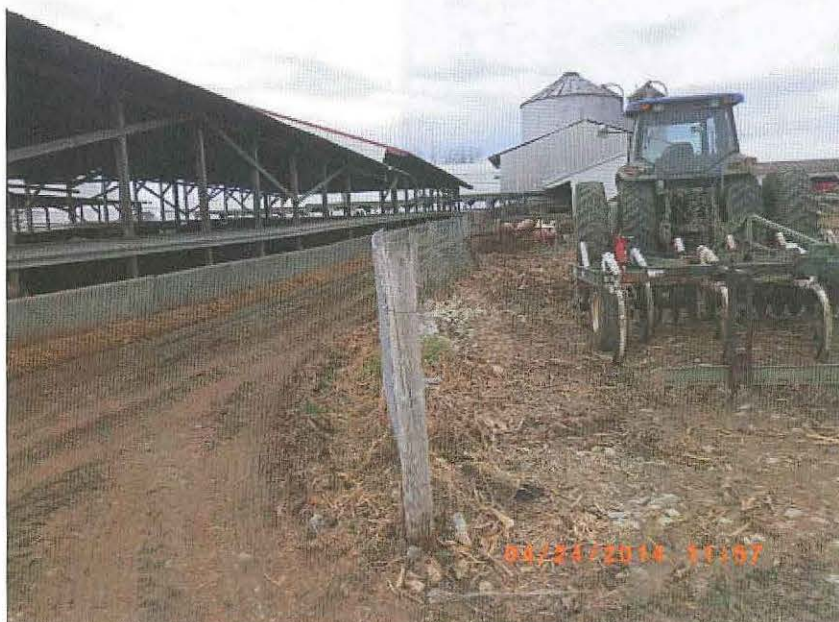
18: IMGP0644

Description: Open lots for pigs is sloped such that it drains to the east.

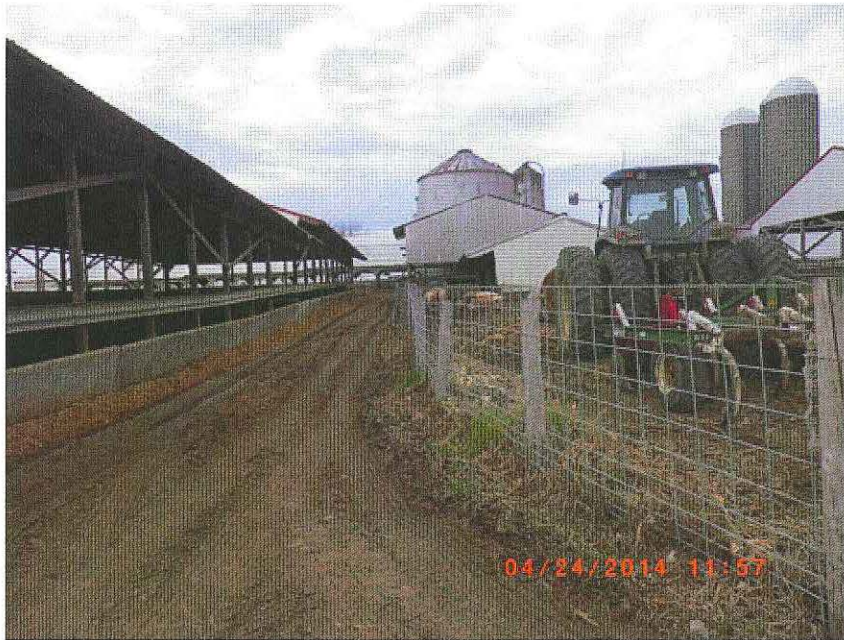
19: IMGP0645

Description: Open lots for pigs is sloped such that it drains to the east.

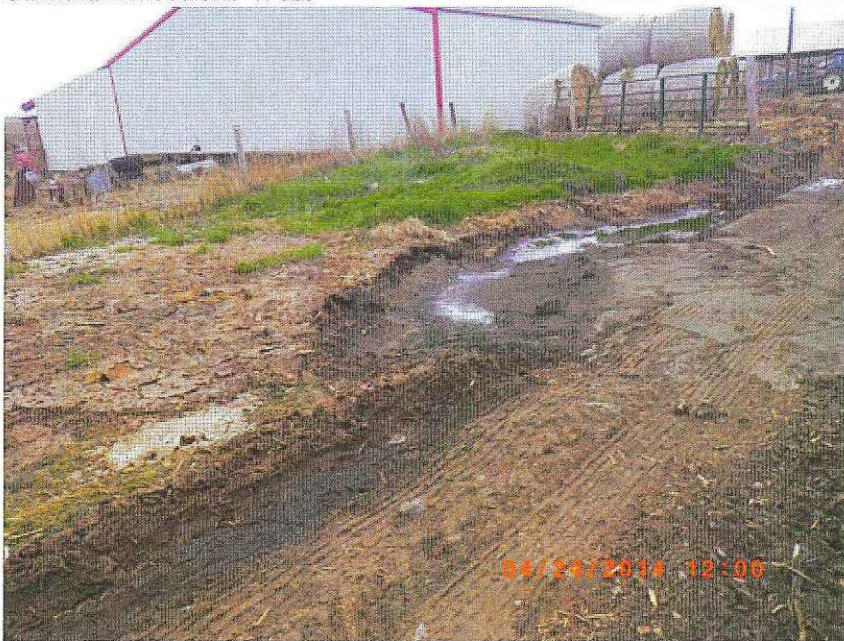
20: IMGP0646

I observed solids buildup and ponding of manure and process wastewater east of the Bruce Barn (Attachment 2: IMGP0646; IMGP0648). The open lots around the Bruce Barn and Robbie's Pen drained through Bruce Barn into this area before flowing into the field to the northeast of Bruce Barn (Attachment 2: IMGP0647) ^{Ex. 6. (Personal Privacy)} said that in the past they have placed hay bales into drainage pathway through the field to reduce runoff of manure from these open lots. The drainage pathway in the field flows to Spring Brook. The push out of manure was observed in the northeast corner of Bruce Barn (Attachment 2: IMGP0649). The surface runoff flows east. The facility had a stack of manure between Bruce Barn and Robbie's Pen (Attachment 2: IMGP0650). There was no containment for process wastewater generated at the manure stack.

Description: Manure and process wastewater was observed east of the Bruce Barn. This area is sloped such that drainage would flow northeast through the field to Spring Brook. There was no containment system for this manure and process wastewater.

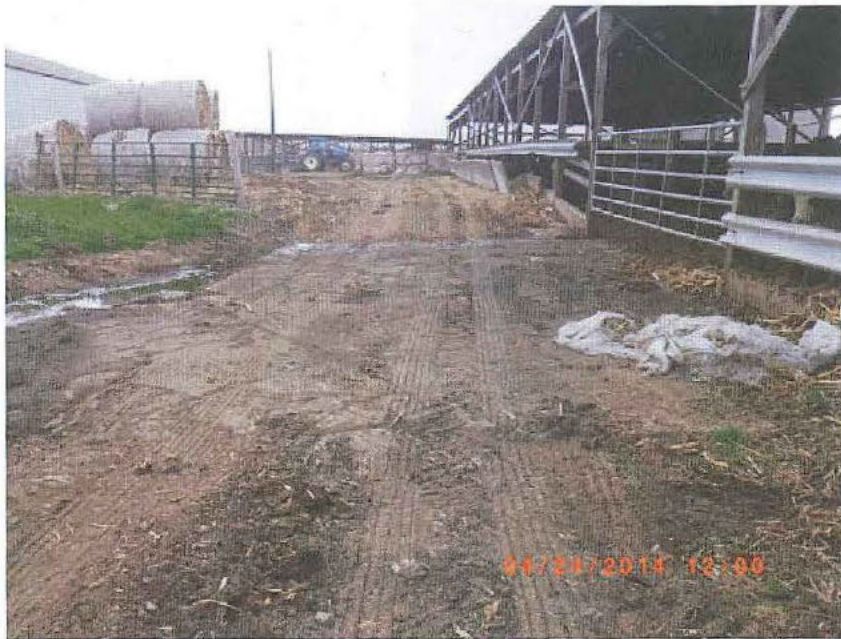
21: IMGP0647

Description: Manure and process wastewater from the Bruce Barn to the east. This area is sloped such that drainage would continue to flow northeast through the field to Spring Brook.

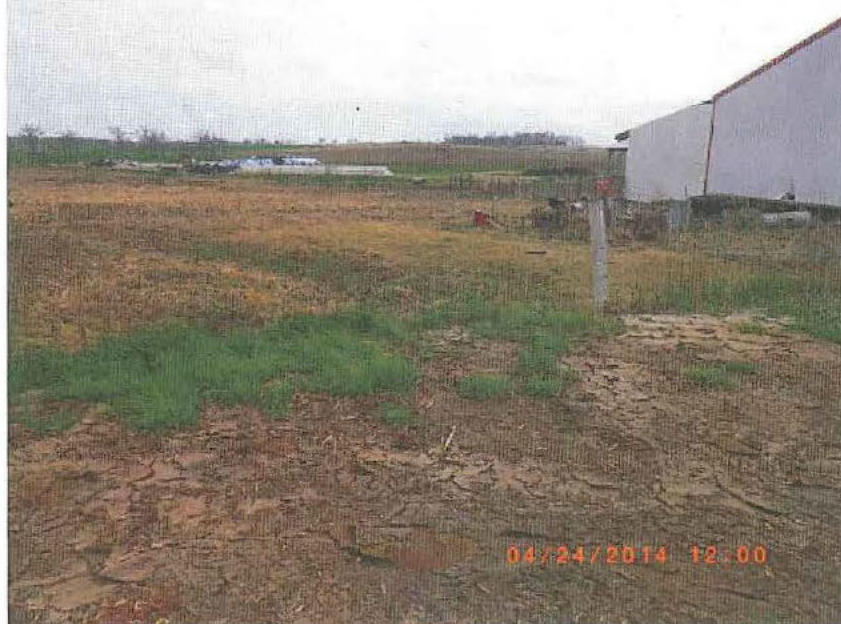
22: IMGP0648

Description: The manure solids can be seen in the area east of the Bruce Barn. Mr. Ex. 6. (Personal Privacy) Ex. 6. (Personal Privacy) said that they have put round bails in the field northeast of the Bruce Barn to reduce the solids in stormwater that flowed from the areas east of the Bruce Barn. There were no round bails in the field during the inspection.

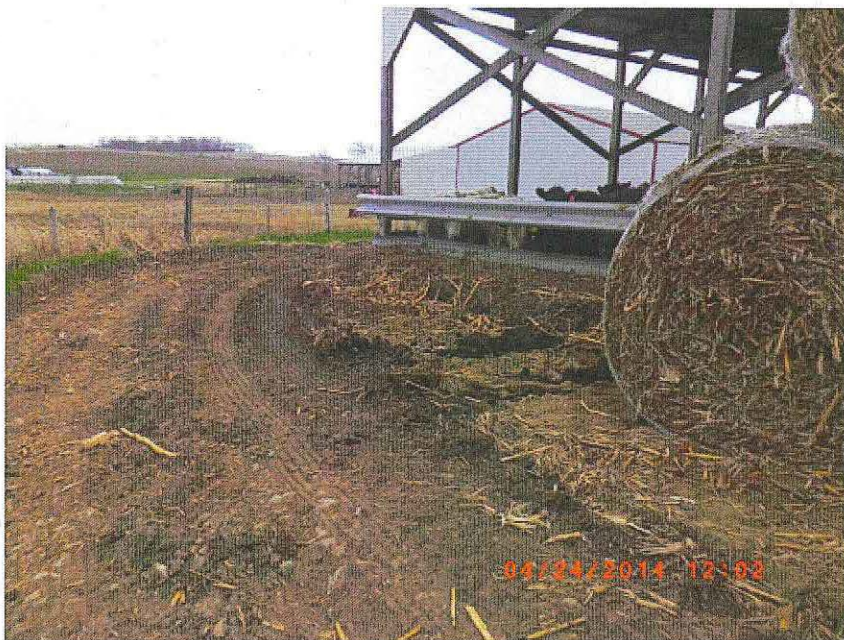
23: IMGP0649

Description: Manure and bedding were pushed out on the North side of the Bruce Barn.

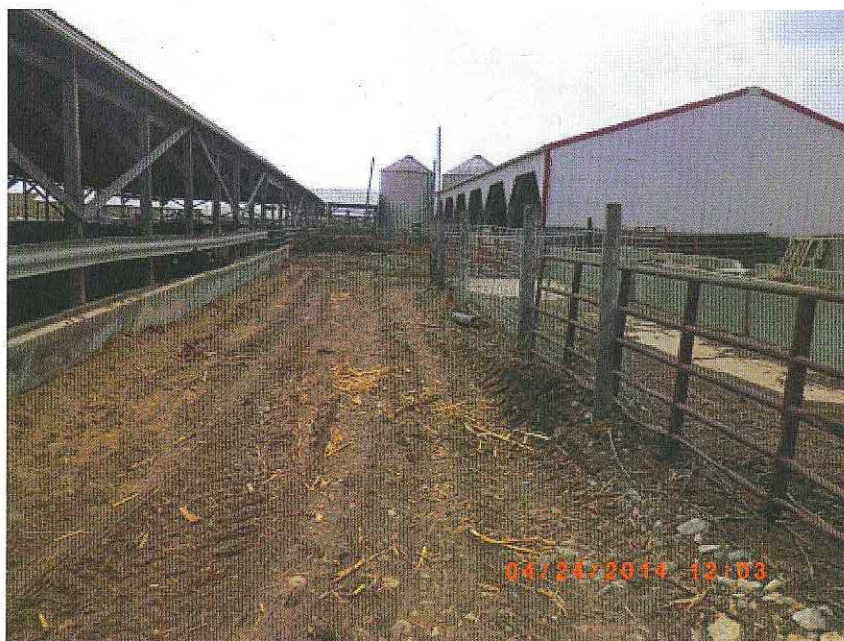
24: IMGP0650

Description: Pile of manure stacked west of the Bruce Barn. Open lots drained to the east.

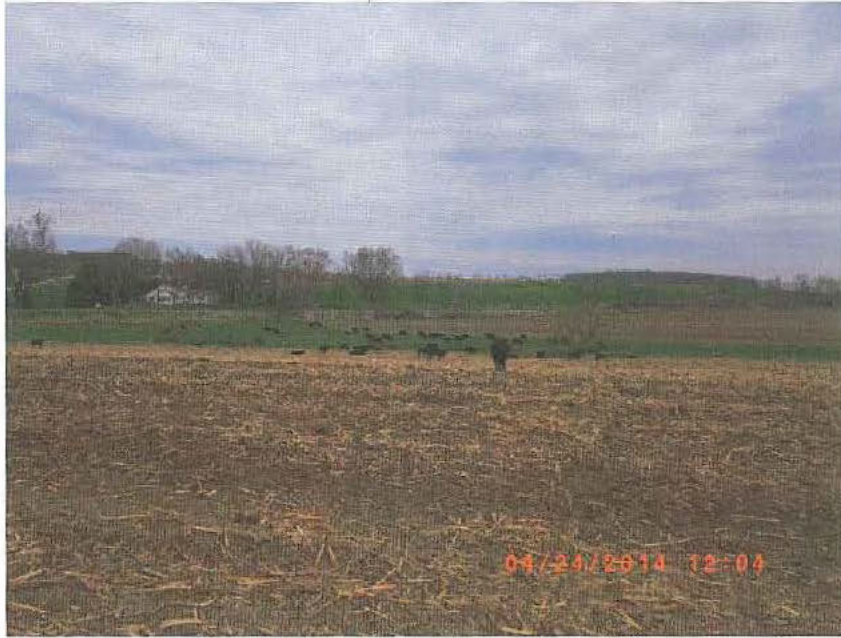
25: IMGP0651

We continued to the feed storage bunkers on the east end of the facility. Throughout the pasture to the north and east of the production area, cattle had direct access to Spring Brook (Attachment 2: IMGP0651). On the east corner of the feed bunkers there was a pipe which diverted process wastewater to a 4,000 gallon reception tank (Attachment 2: IMGP0653). During the inspection, the reception tank was full. The overflow from the reception tank would flow to the east and connect with a gully that flows to Spring Brook (Attachment 2: IMGP0654; IMGP0659). I observed a small stack of waste feed to the south of the feed bunkers (Attachment 2: IMGP0662).

Description: Cattle on pasture had direct access to Spring Brook.

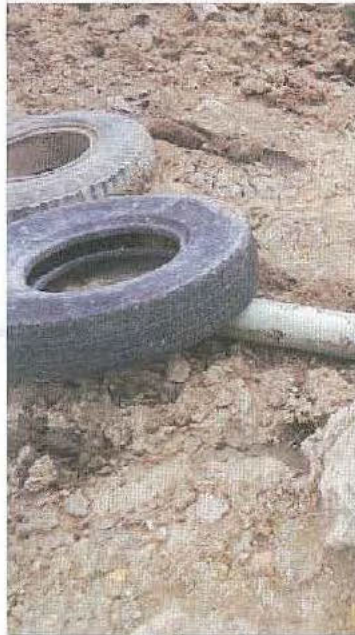
26: IMGP0652

Description: The bunker feed storage area drained through a pipe to an underground tank. The tank was full during the inspection. Any additional process wastewater flow to the tank would cause an overflow and flow east and then north to Spring Brook. The tire marks the inlet of the underground tank.

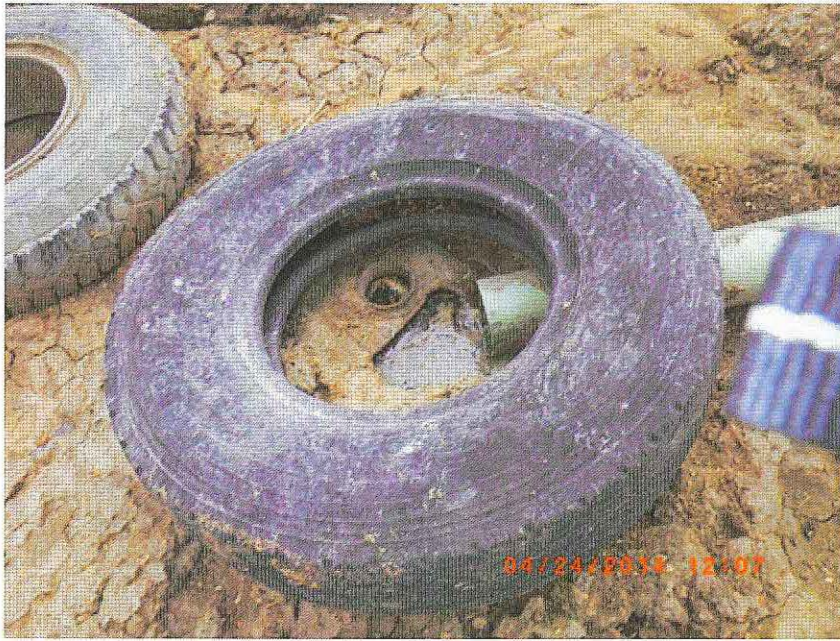
27: IMGP0653

Description: The bunker feed storage area drained through a pipe to an underground tank. The tank was full during the inspection. Any additional process wastewater flow to the tank would cause an overflow and flow east and then north to Spring Brook. The tire marks the inlet of the underground tank.

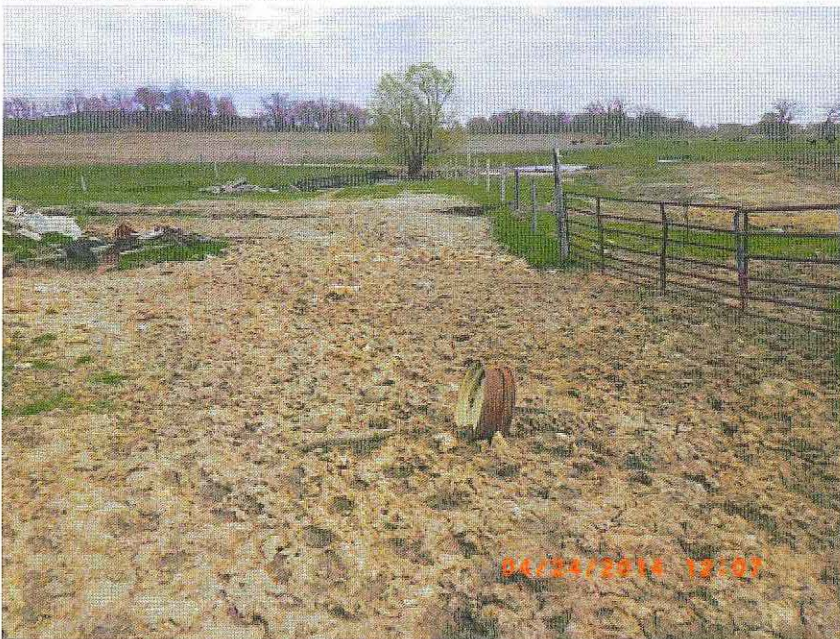
28: IMGP0654

Description: The feed storage bunkers drain east through this area that did not have any vegetation.

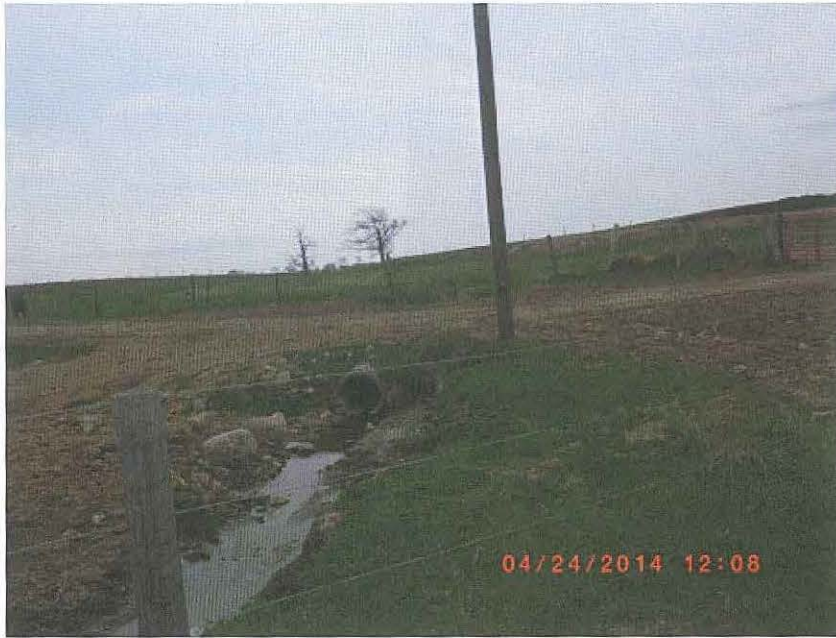
29: IMGP0655

Description: The drainage pathways along the south and east end of the facility eventually drains through this culvert and then through a gulley to Spring Brook.

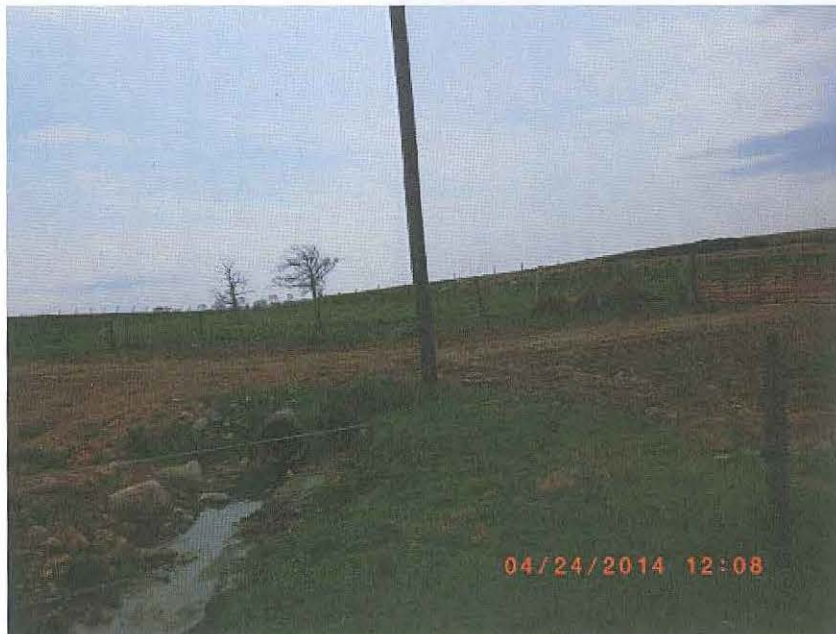
30: IMGP0656

Description: The drainage pathways along the south and east end of the facility eventually drains through this culvert and then through a gulley to Spring Brook.

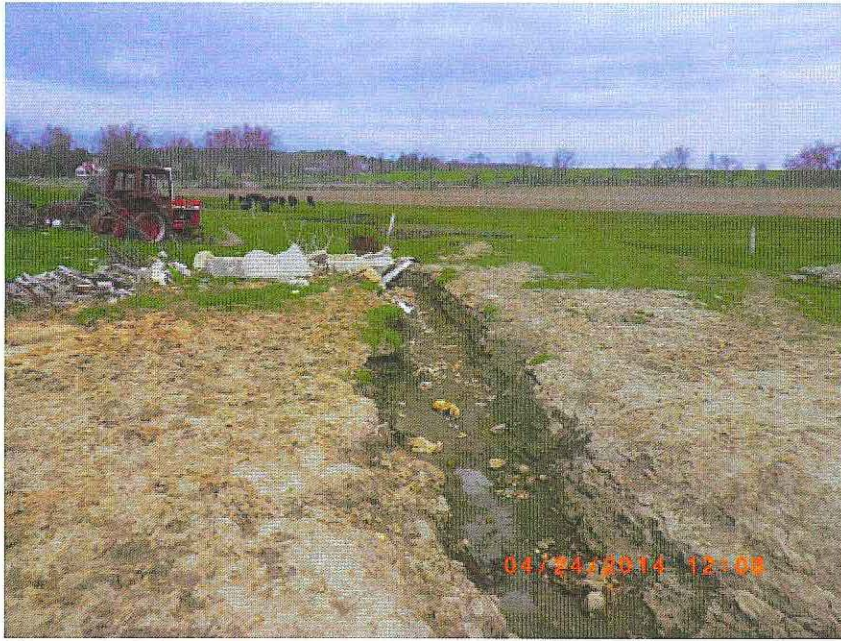
31: IMGP0657

Description: The gully drains north to Spring Brook.

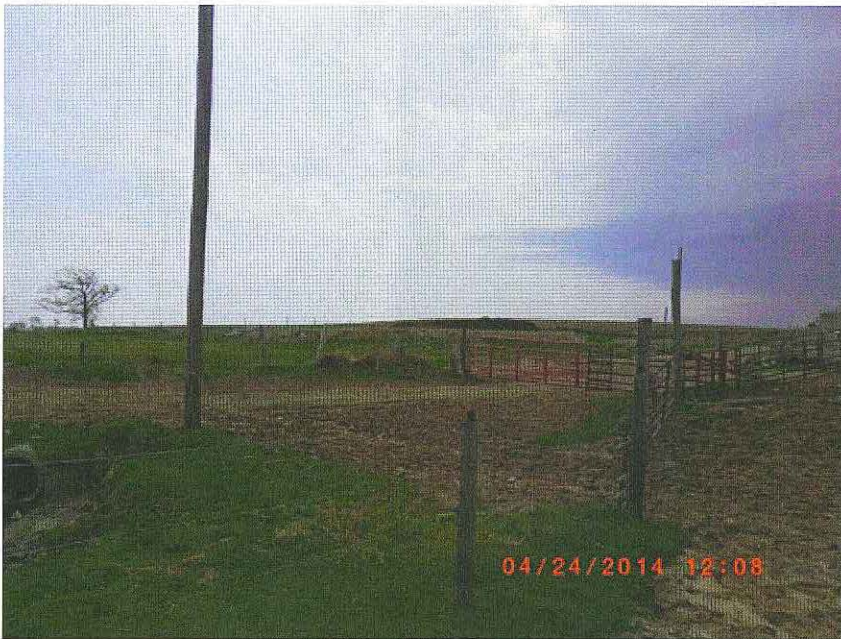
32: IMGP0658

Description: A compost pile was observed south of the Feed Bunkers.

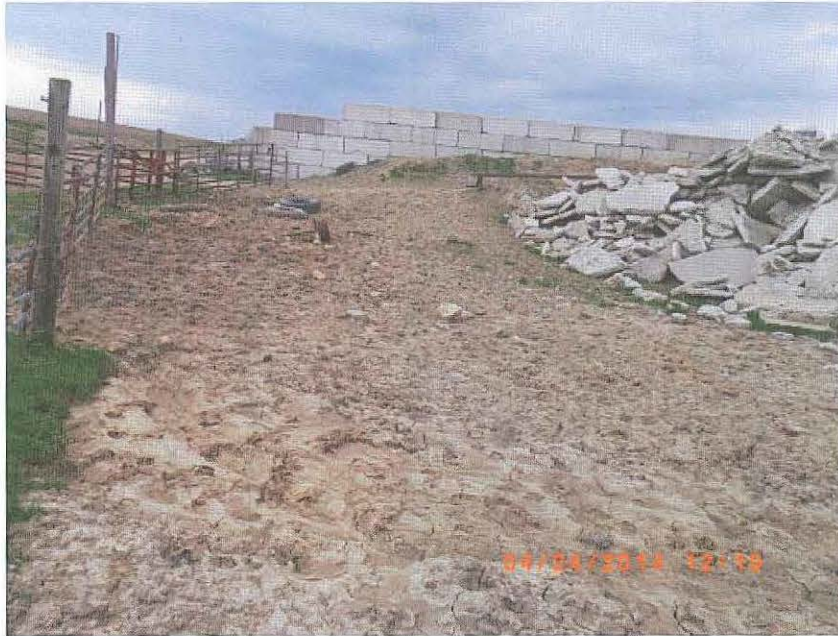
33: IMGP0659

Description: The tank that contains process wastewater from the feed bunkers is under the tires. The overflow of process wastewater from the tank would flow northeast through this unvegetated area to the gulley.

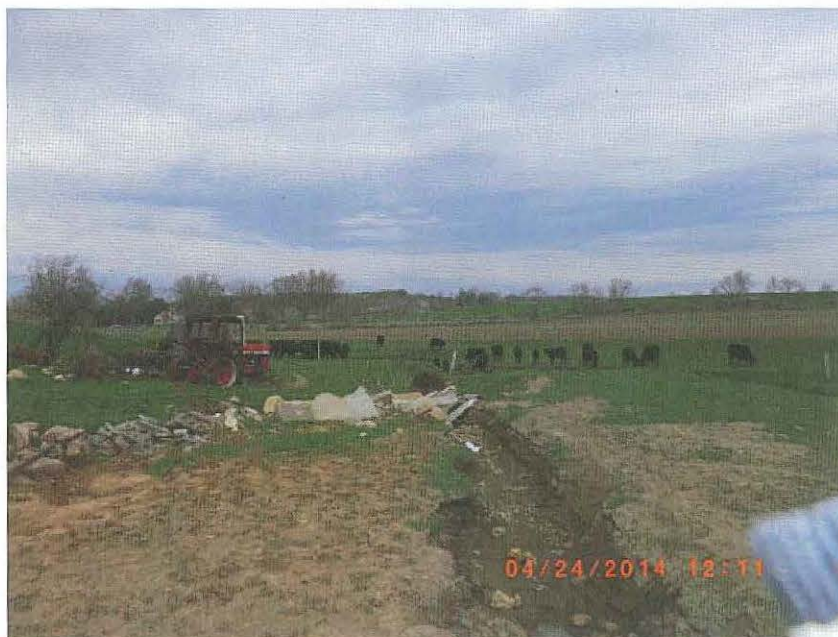
34: IMGP0660

Description: The gulley drains north to Spring Brook.

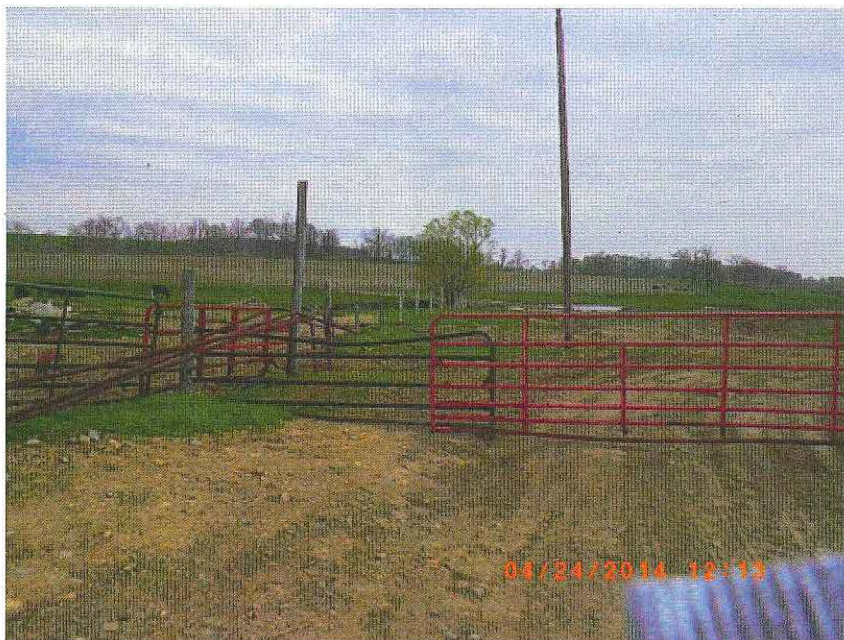
35: IMGP0661

Description: The culvert that drains the south and east side of the facility goes under this access way.

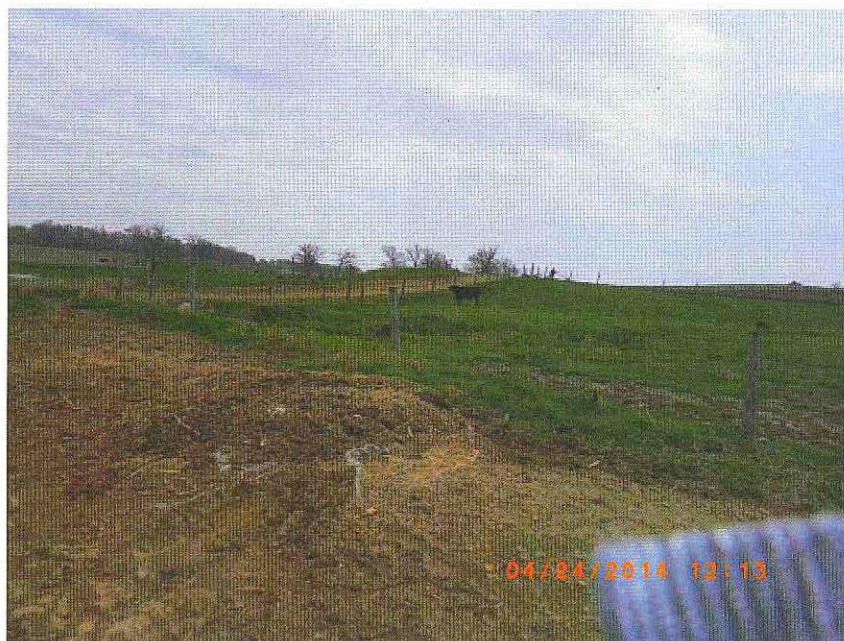
36: IMGP0662

Description: Waste feed southeast of Feed Bunkers. The culvert inlet that drains the south and east sides of the facility is located in the field.

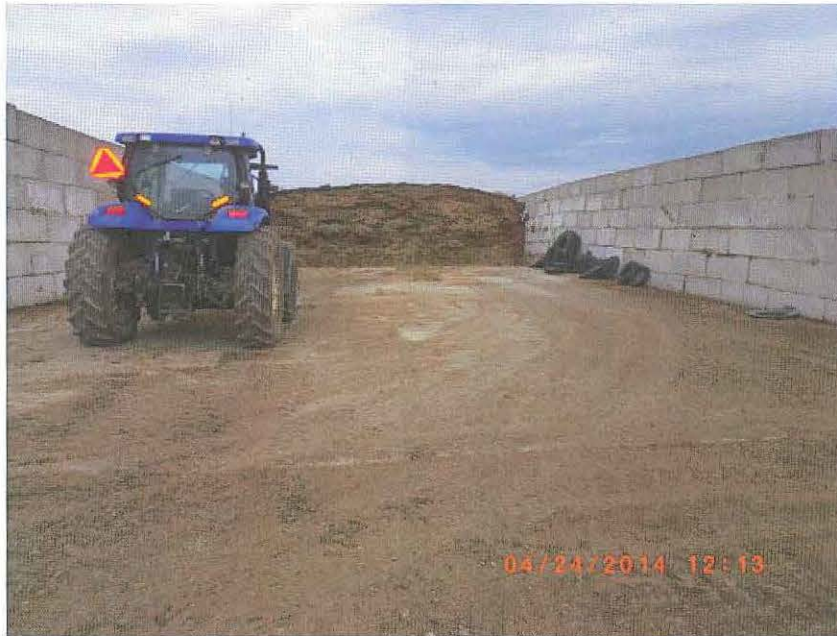
37: IMGP0663

Description: Process wastewater from the Feed Bunker is drained through a four inch PVC pipe to an underground tank that was full during the inspection.

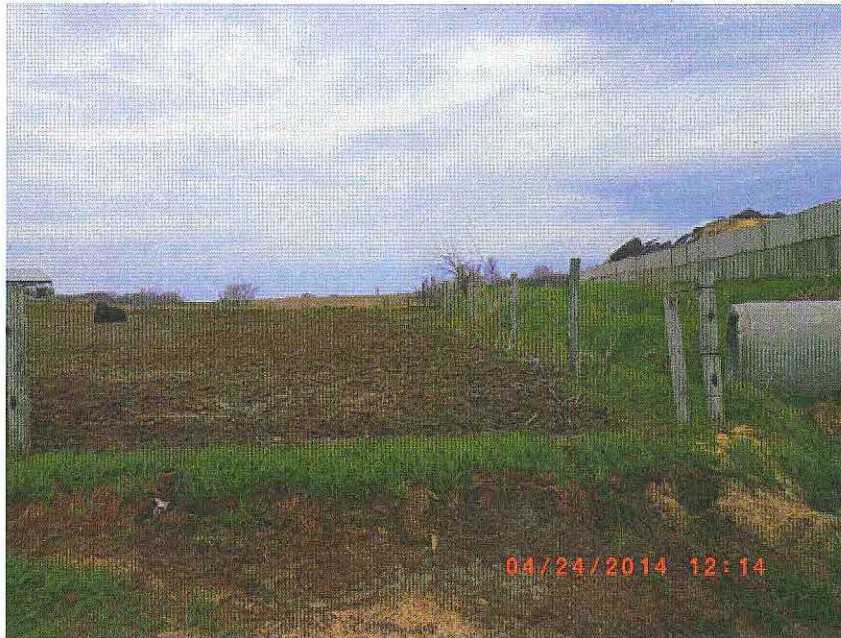
39: IMGP0665

I observed manure and feed from the East Lot that had run off the southeast corner and into the access road (Attachment 2: IMGP0665). This area appeared to drain to the east (Attachment 2: IMGP0666). In the lot to the south of the East Lot, I observed feed solids scattered throughout a feeding area (Attachment 2: IMGP0667). This area drained to the east. A large compost pile was located within the lot south of the East Lot (Attachment 2: IMGP0668; IMGP0673). I observe that there was no containment for any process wastewater generated at the compost pile. The compost area drained to the northeast to Spring Brook. I asked Ex. 6. (Personal Privacy) what kind of operational procedures he used for the compost pile. He said he just added carcasses and covered them. He did not have a monitoring or inspection plan for the compost pile. The compost pile was not in an approved structure.

Description: Feed lot is sloped such that surface drainage flows east. Manure and feed waste were observed on the East side of the open lot.

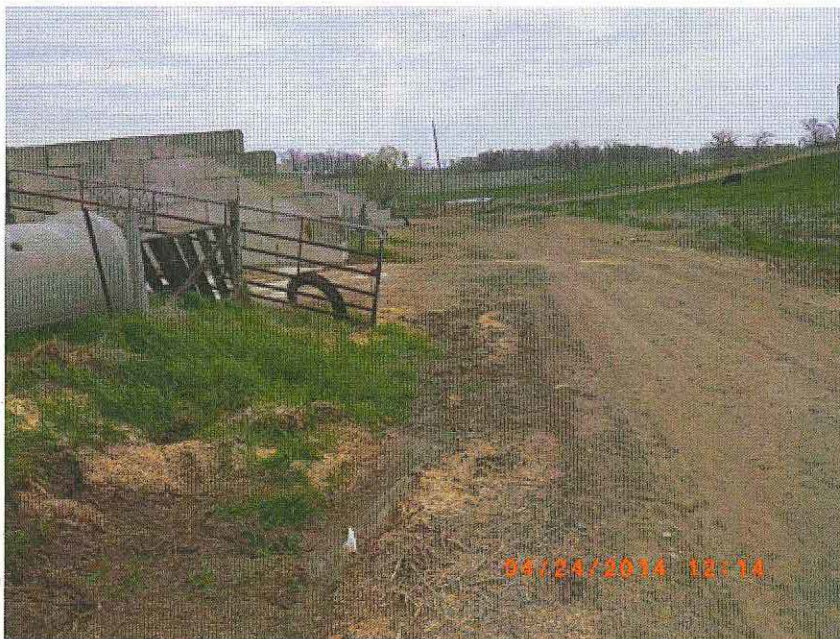
40: IMGP0666

Description: A drainage pathway from the East Lot is sloped to the east.

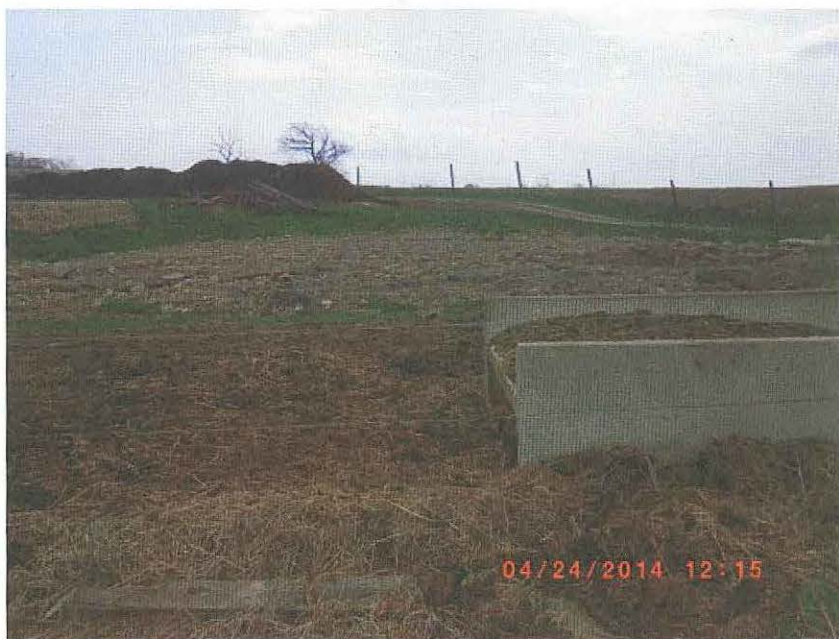
41: IMGP0667

Description: The mortality compost pile can be observed in the background. The mortality compost pile was not covered. Feed was observed on the ground.
